D-691
Tubman House
East New Market
private

Maryland Historical Trust State Historic Sites Inventory Form

historic TUBMAN HOUSE

HOWARD SIMMONS HOUSE

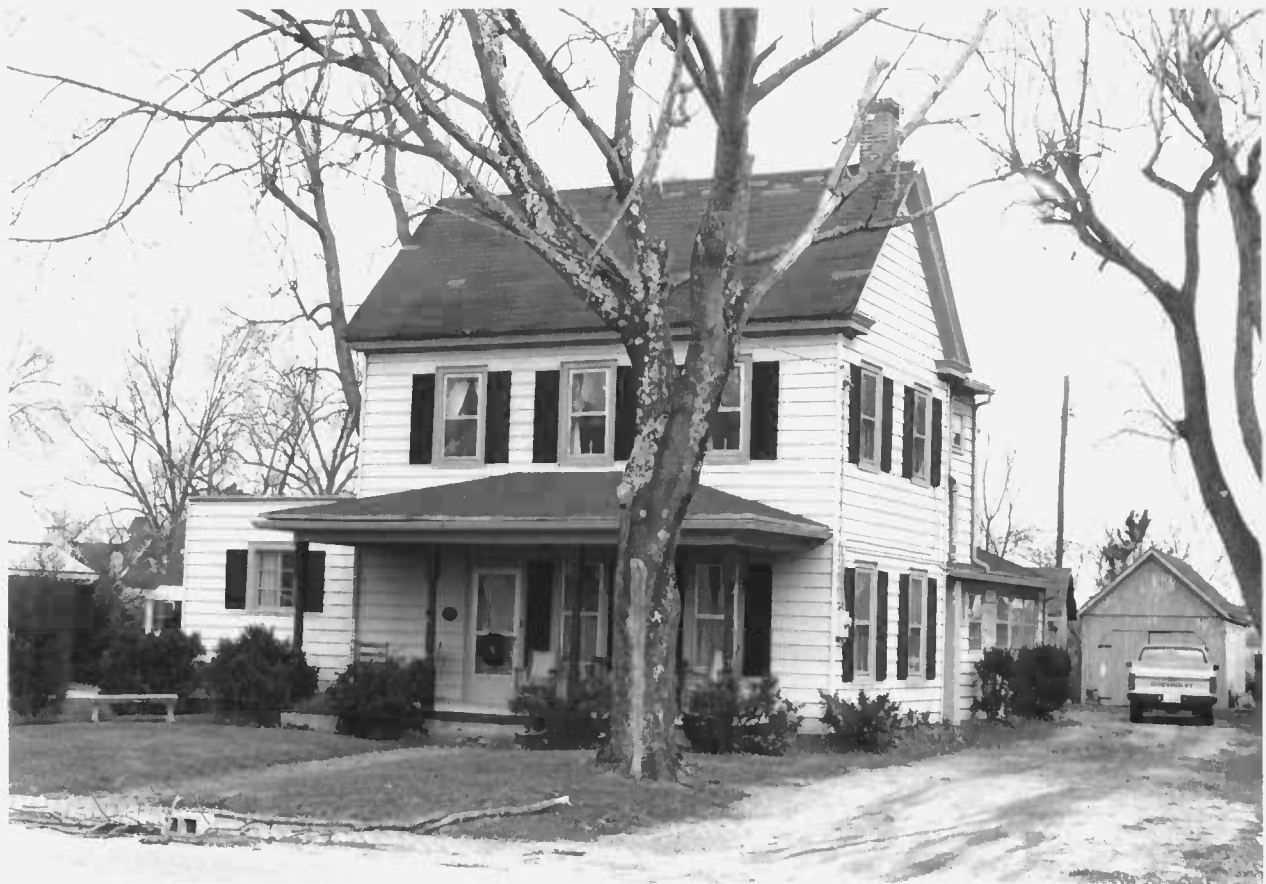
South elevation

The south (main) facade is an asymmetrical three-bay elevation with a side entrance and flanking single-pane sash windows. The front door is distinguished by an oval glass, and the windows are flanked by aluminum shutters. Stretching across the entire first floor is a turned post, hip roof porch. The second floor is lighted by three unevenly spaced single-pane sash windows. The cornice is boxed and trimmed with period molding.
